The Forsmark incident 25th July 2006

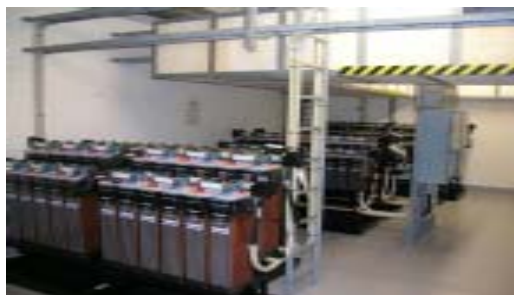
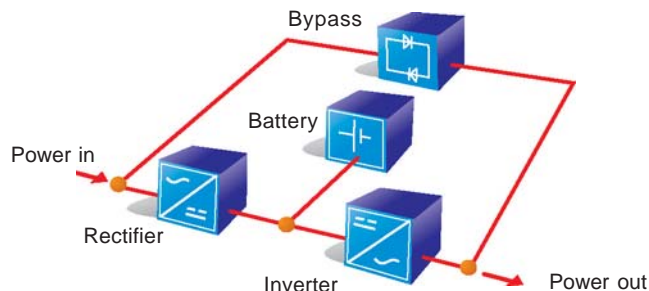
Uninterruptable Power Supply (UPS)

For the UPS systems in two subs, A and B, the overvoltage resulted in failure of the units and loss of the 220 V supply. Subs C and D withstood the voltage variations and continued to operate, which meant that equipment supplied from them operated as intended.

The various integral component protection systems in the rectifiers and inverters caused two of the four UPS systems to be knocked out.

The UPS systems are intended to supply the low voltage AC systems with battery backed no break power during and after a fault, for a period of at least two hours. During normal operation, the batteries in each UPS are float charged from the normal AC system via rectifiers. In the event of loss of power supply, the batteries supply the safety equipment powered from the system with low voltage AC via inverters. Both the rectifiers and the inverters incorporate various internal component protection features.

The battery backed no break AC system is intended to supply equipment that is essential for safe shutdown of the reactor. However, in fact, this incident resulted in a loss of power from the UPS system on subs A and B.

However, the voltage variation that actually occurred was much greater, and so it was to be expected that the UPS systems could not deal with it.
